**The Second Tibetan Plateau  
Scientific Expedition and  
Research (STEP)**

# **Supraglacial lake outburst floods in the China-Nepal border this July**

**Weicai Wang**

**Institute of Tibetan Plateau Research, CAS**

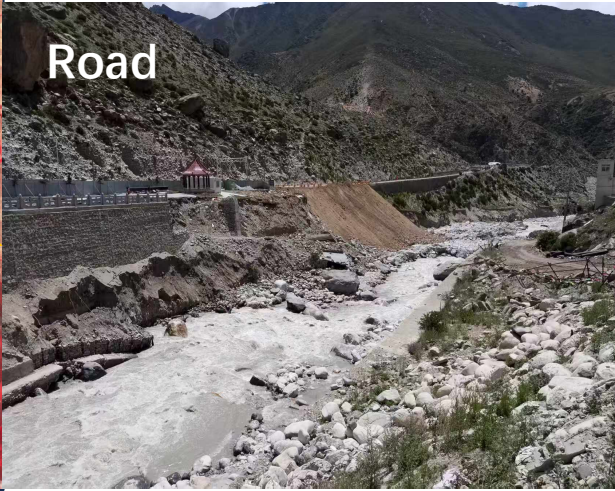
2025-07-05 00:00 - 2025-07-05 23:59, Sentinel-2 L1C, False color

2025.7.8  
Purepu

2025.7.7  
Nielangpu

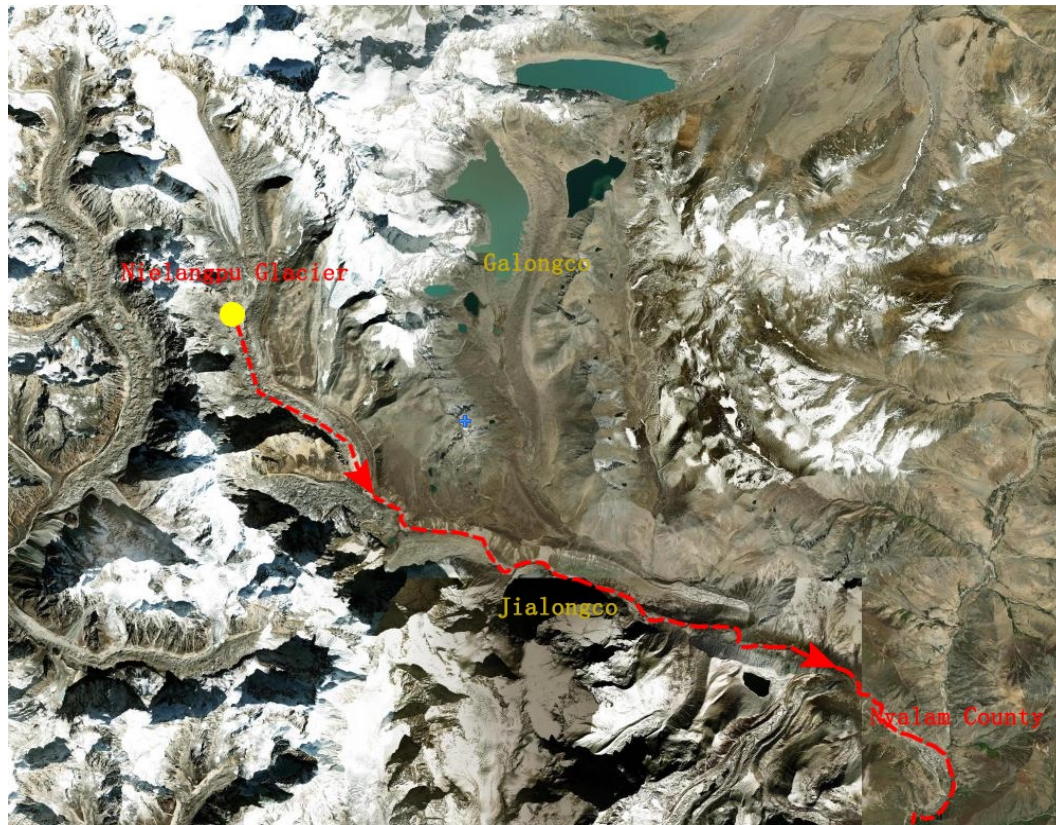
Locations of Nielangpu supraglacial lake and Nyalam County

The GLOF reached Nyalam County at **~08:00 local time** on 7 July. Owing to the timely warning and the limited flood magnitude, **no casualties or infrastructure damage** were reported

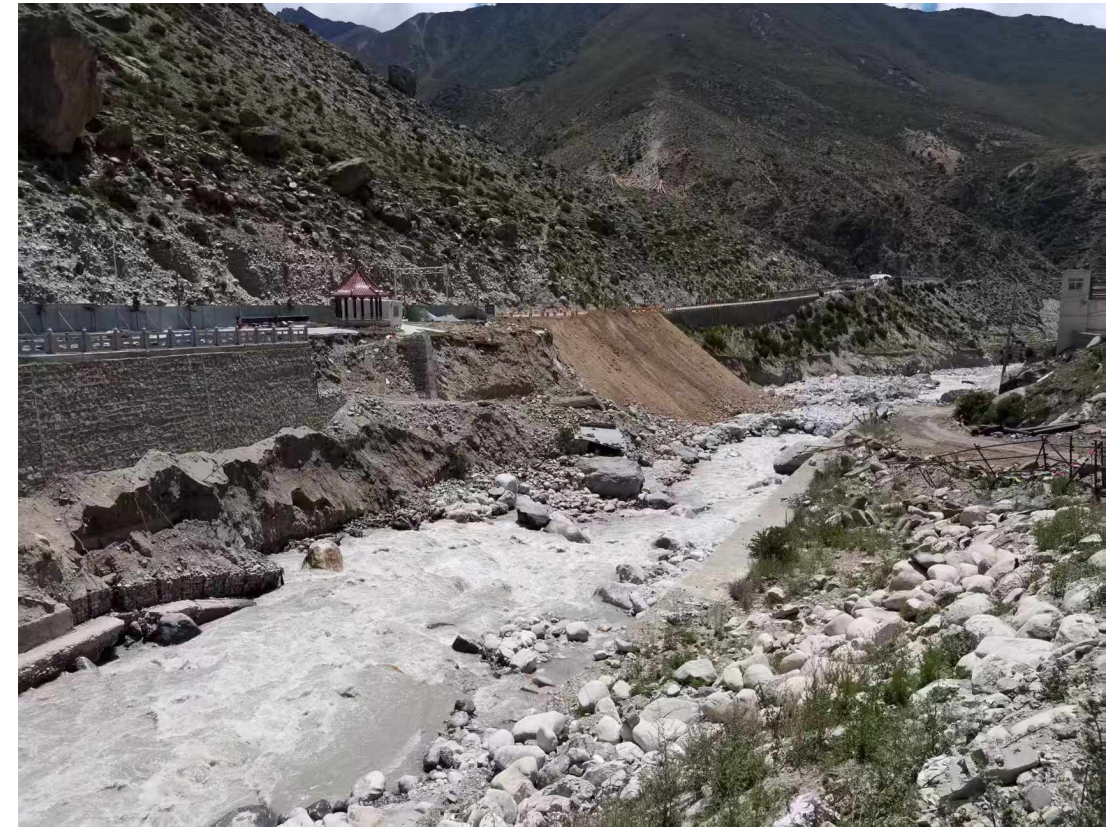
Partial river Embankments were washed away

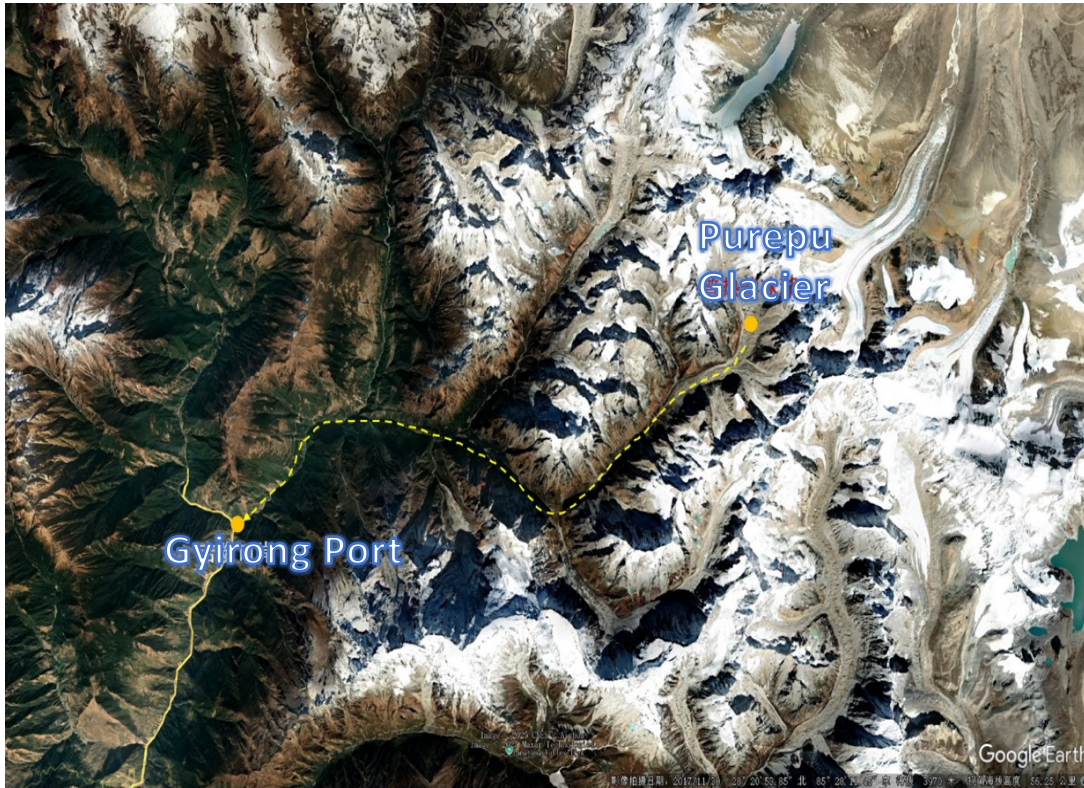
Locations of Purepu supraglacial lake and Gyirong Port

The GLOF reached Gyirong Port **at ~05:00 local time** on 8 July. At least **18 fatalities** were reported, and thousands of residents were evacuated in this event. Many bridges, roads, and **hydropower projects** were ruined, causing a direct economic loss of **USD 53 million**.

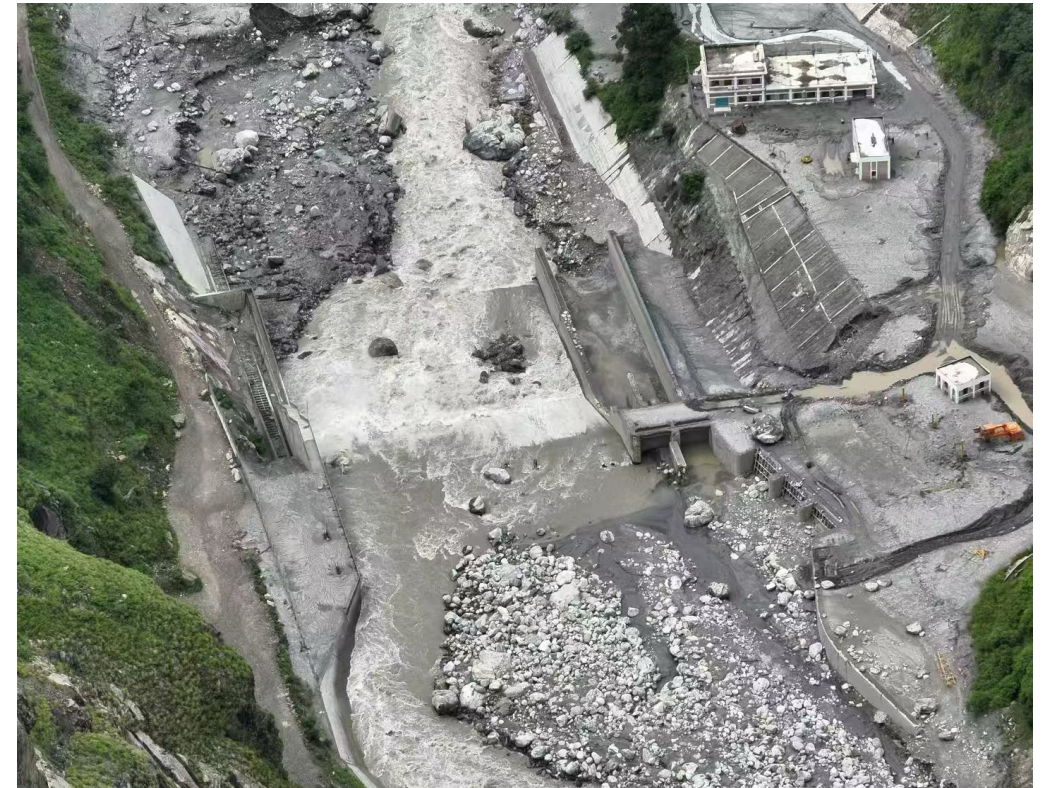
Destroyed hydropower plant

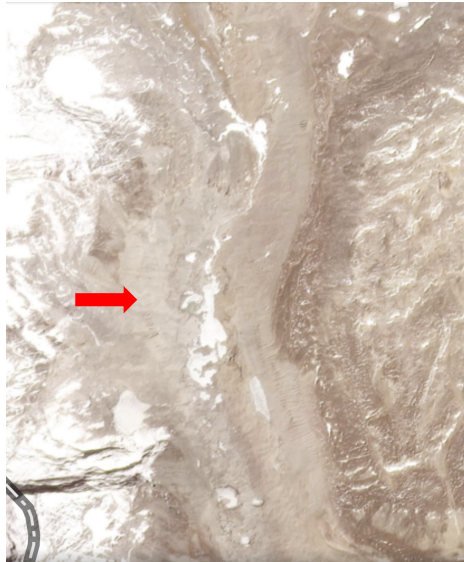
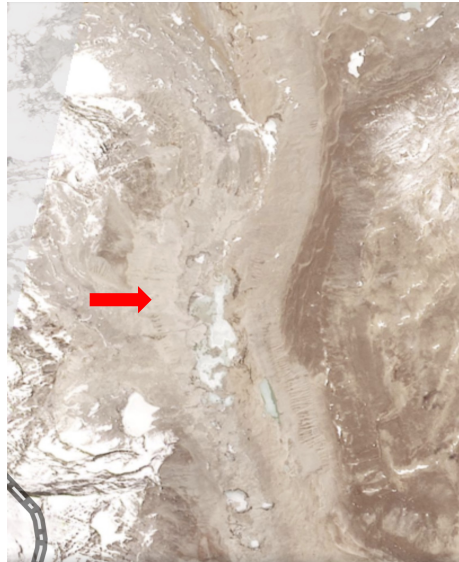
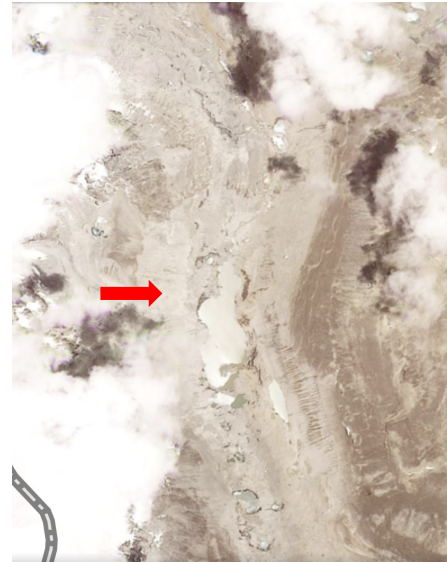
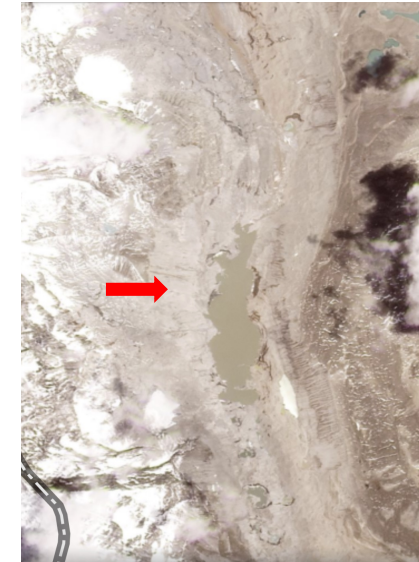
From January to late April 2025, the Nielangpu supraglacial lake area increased slowly. Thereafter, the lake experienced a near-exponential growth, **reaching 0.64 km<sup>2</sup> by 7 July**, equivalent to an expansion rate of 7300 m<sup>2</sup>·d<sup>-1</sup>

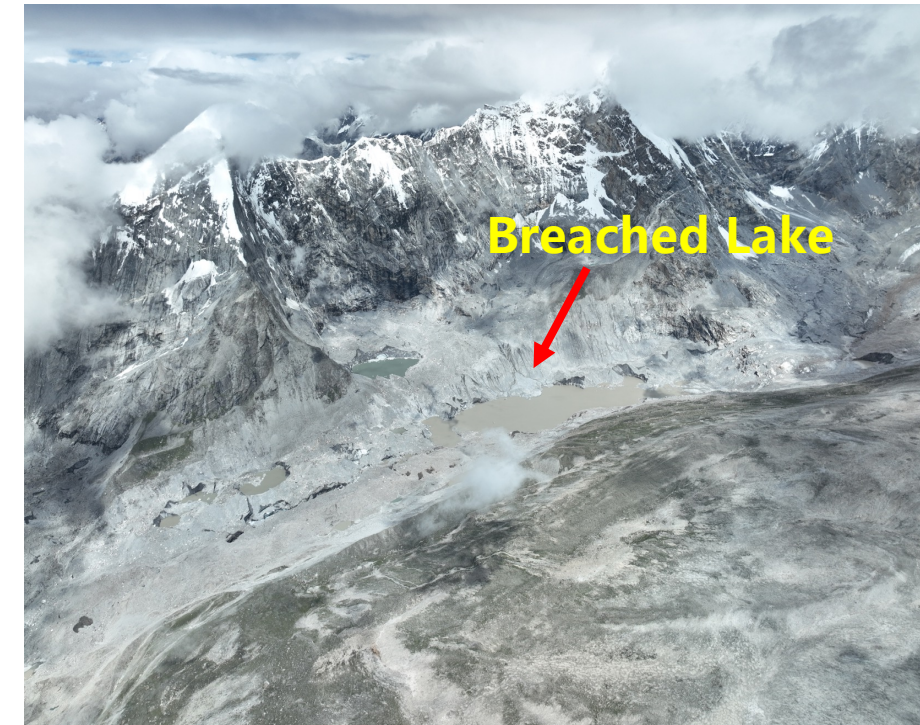
- The bathymetry of the Nielangpu supraglacial lake showed a total volume of  $11.8 \times 10^6 \text{ m}^3$  before outburst.
- After outburst, the lake area had decreased to  $0.51 \text{ km}^2$ . This implies a rapid release of  $3.8 \times 10^6 \text{ m}^3$  of water.

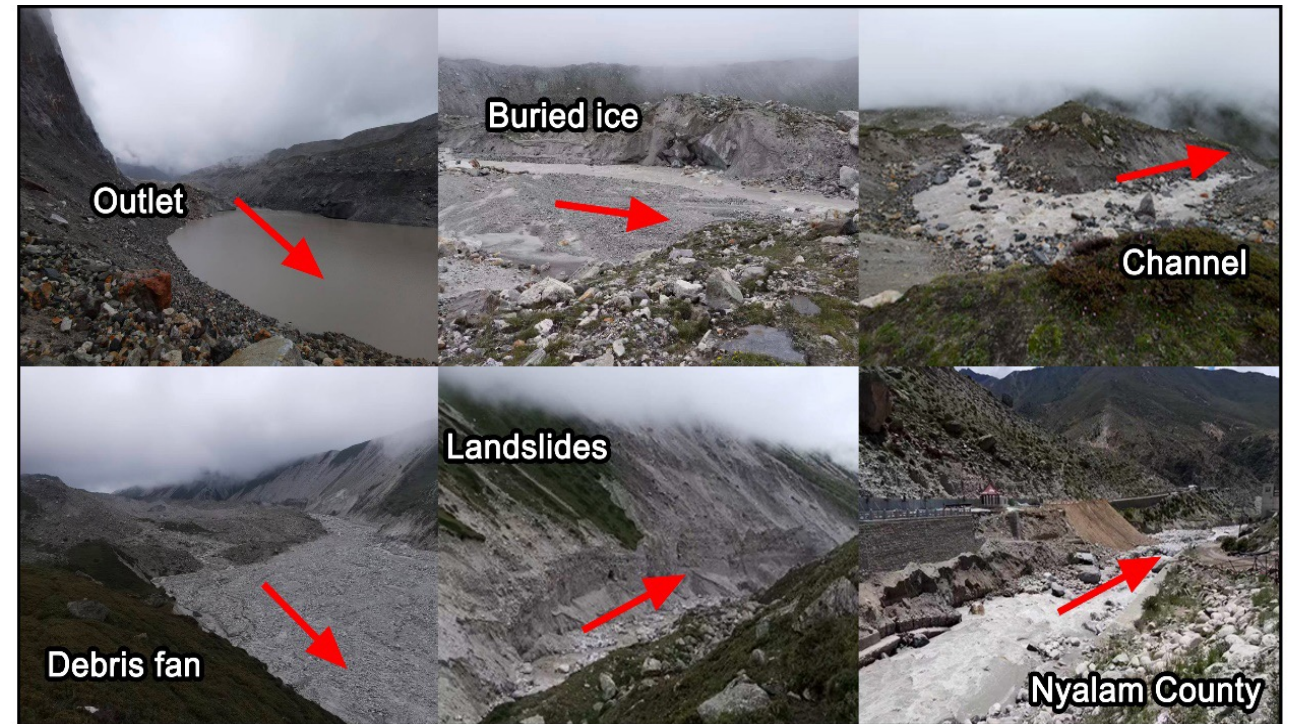
- The initial rapid discharge caused downstream river overtopping, submerging approximately  $1.67 \pm 0.46 \text{ km}^2$  of floodplain.
- Post-event field investigations identified several active, small-scale landslides along the upstream riverbanks, yet **no obvious channel erosions** were generated.

Comparison of the lake and the downstream river channel before and after the outburst

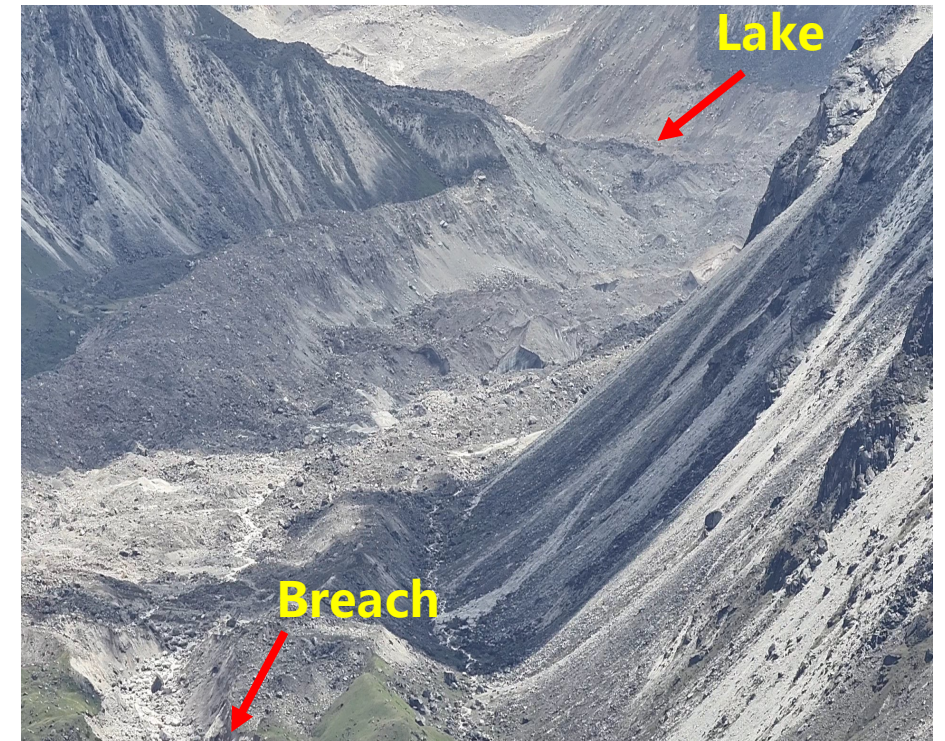
- The lake volume was estimated to be  $9.1 \times 10^6 \text{ m}^3$  and the maximum water depth reached **50 m** before outburst.
- After outburst, the residual lake area had decreased to  $0.34 \text{ km}^2$ , indicating a release of  $7.2 \times 10^6 \text{ m}^3$  of water.

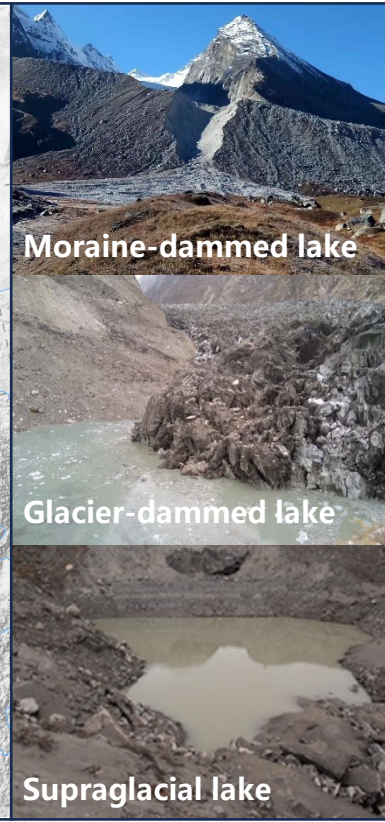
GLOF originating from occasional giant supraglacial lakes is a new type of GLOF

**1. High magnitude:** The pre-failure lake area is one order of magnitude than other counterparts

**2. Heavy destructiveness:** Characterized by flash floods, with strong impact downstream

**3. Periodic drainage:** Formed and drained because of glacier melting and englacial drainage conduits opening.
